BOMBS AWAY

This radical renovation included both a seismic update and a complete cosmetic makeover

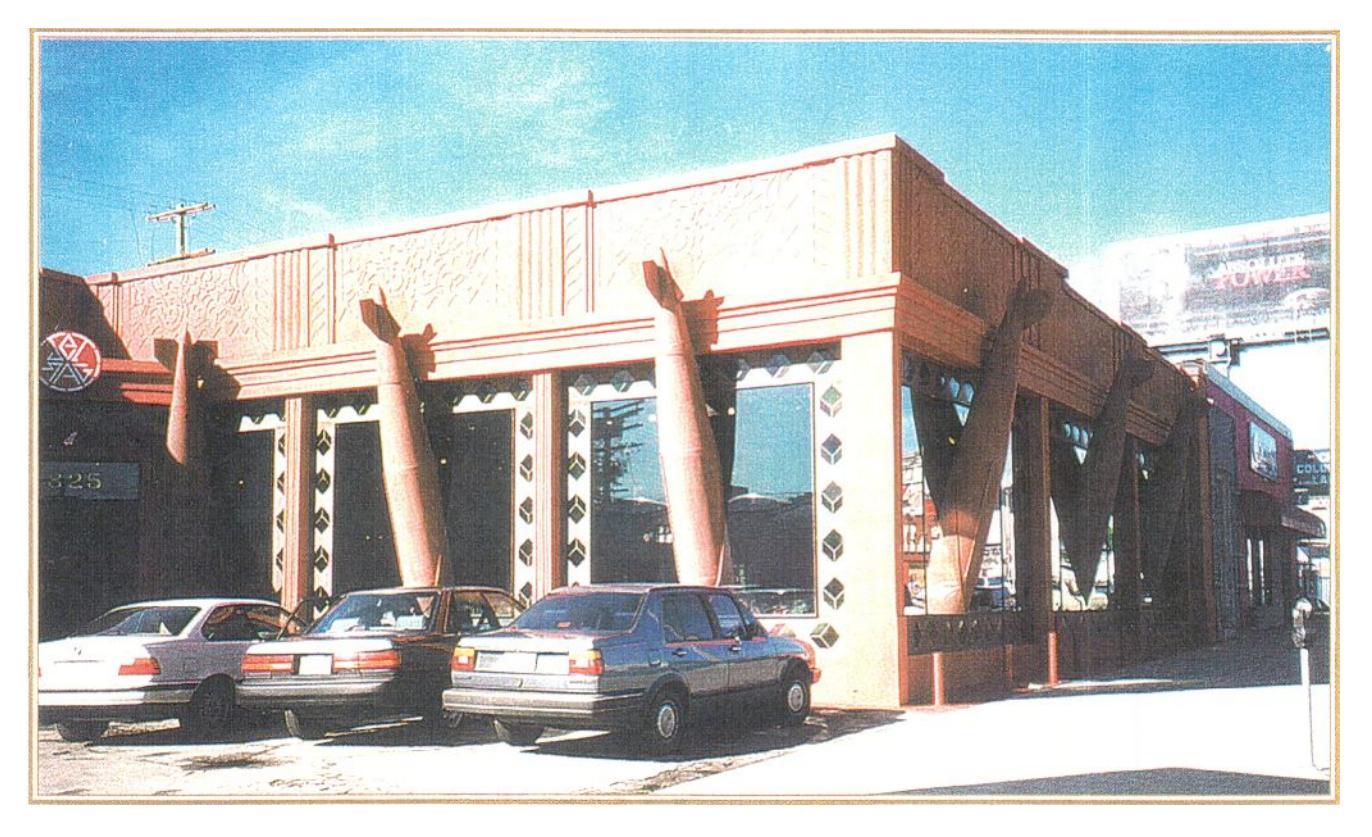
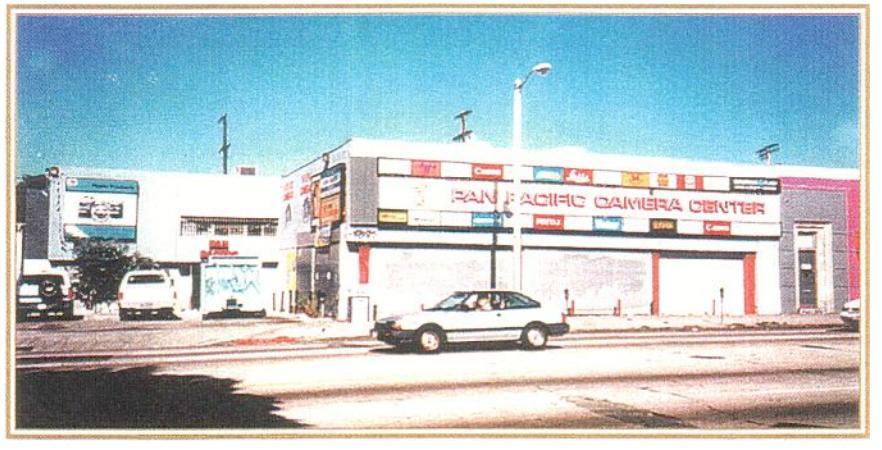
Pictured on the opposite page is the original building and the newly renovated clothing store.

The existing 50-year-old building at 825 N. La Brea Ave. near downtown Los Angeles was a one-story unreinforced masonry retail sales building with an approximate total area (including a mezzanine) of 10,000 sq. ft. within an "L" shaped floor plan. The structure has a roof diaphragm composed of a 1" x 6" straight sheathing supported by built-up wood bowed trusses typically spanned at 20' on center. The foundation consists of continuous concrete footings and a 4"-thick concrete slab floor.

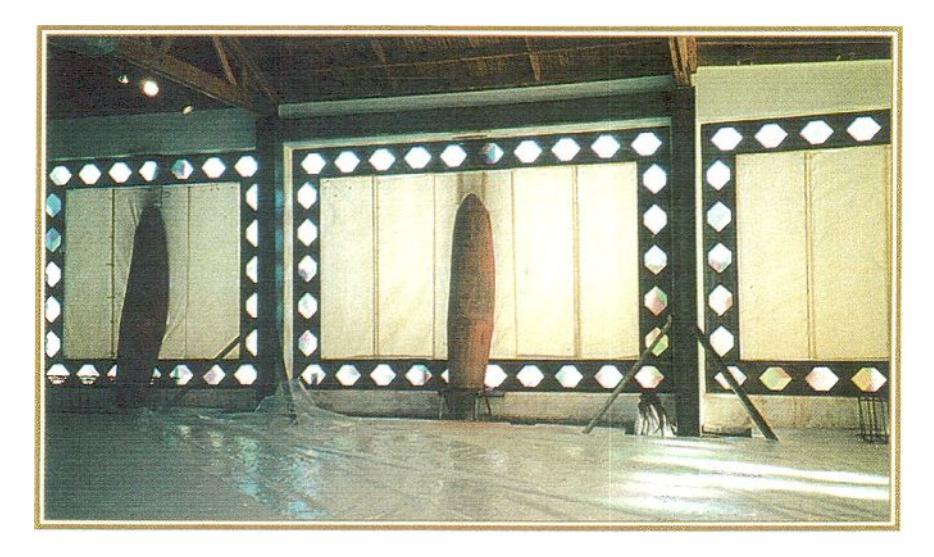
Shown at right top is the special steel moment resisting frame in the N-S direction.

For the seismic upgrade, in addition to the standard roofwall ties and fiber wrapping of the walls, a special steel moment

resisting frame running in the north-south direction was designed. After careful consideration, the Cover Plate Connection referenced in SAC's "Interim Guidelines: Evaluation, Repair, Modification and Design of Welded Steel Moment Frame Sections."

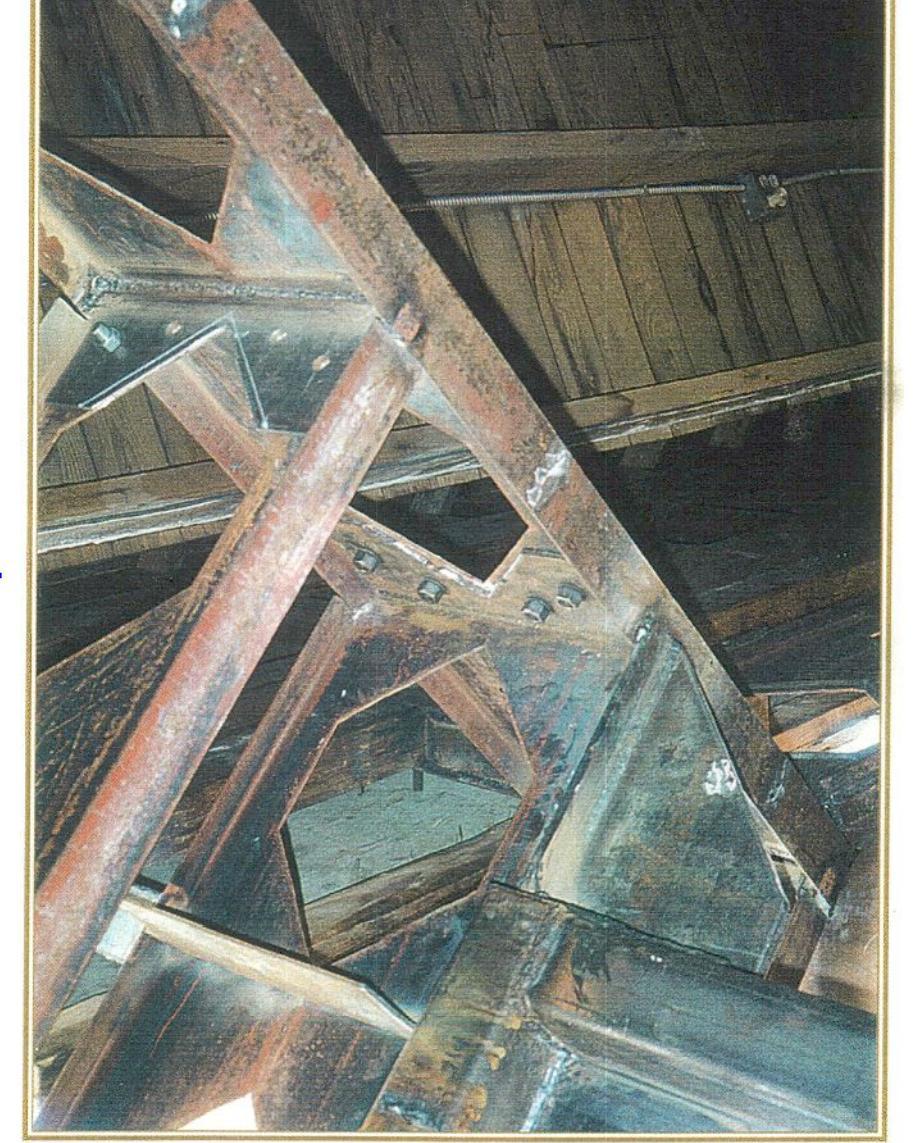
Shown at right bottom is the connection between the steel members.

nections, which were purposely hidden inside the bombs, creating the illusion that the bombs are the structural elements and satisfying the artist's vision and owner's requirements," Esquivel explained. Both welding and bolting were used for the connections, depending on accessibility and aesthetics. Steel straps and steel rods were used to attach the bombs, which were realthough deactivated—World War II bombs, to the existing steel plates at the headers of the windows. "This accomplished the requirements of the artist to create a unique building which appears to have bombs penetrating the middle of each plane of glass window without any visible support."
